Navajo Abandoned Uranium Mine

Site Screen Report

Johnny McCoy 1 AUM Site

Weston Solutions, Inc.

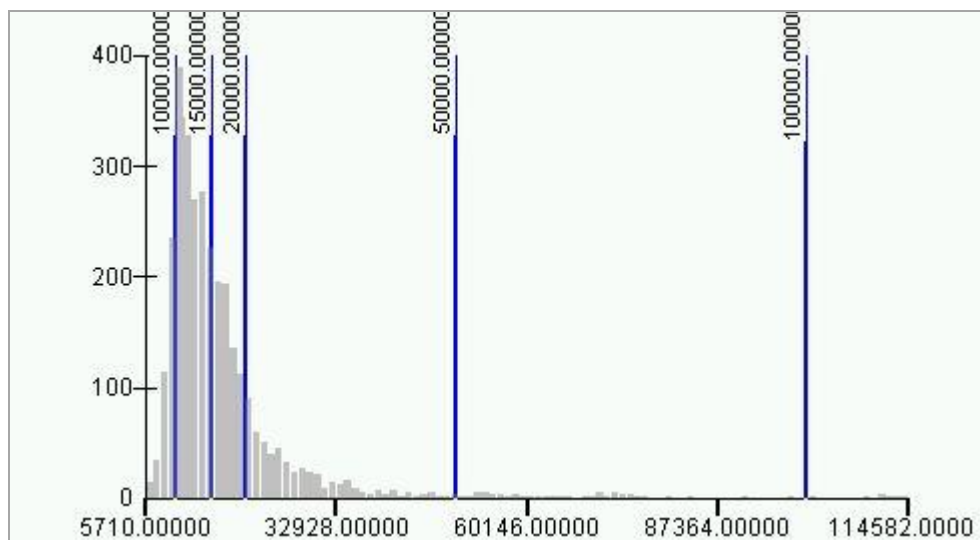
The following chart and statistics were generated by ESRI ArcGIS 9.3.1, and show the general distribution of the site gamma radiation measurements. The horizontal X axis represents the gamma radiation reading levels in cpm (lowest levels to the left). The vertical Y axis represents the frequency of each gamma radiation level.

Count:	3142
Minimum:	5710.00000
Maximum:	114582.00000
Sum:	52978053.00000
Mean:	16861.25175
Median:	14043.00000
Standard Deviation:	10862.48186

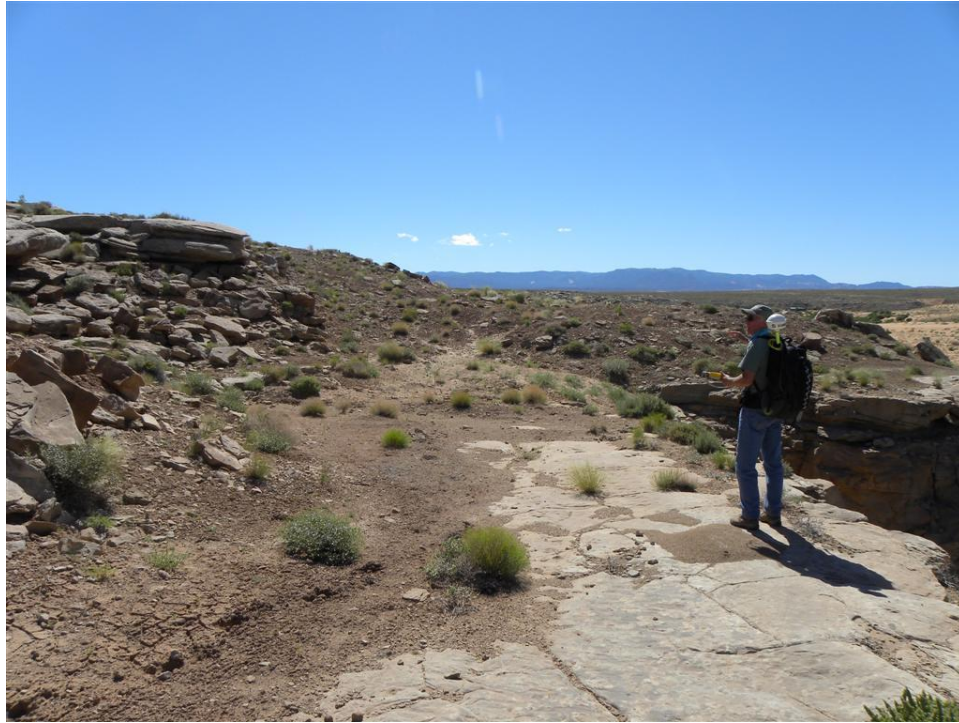
Former trench area in S area of site (covered), 30'x30'

Photo 3. Johnny McCoy 1 site, former trench area

Site reclaimed by AML in 1997, covered trench and shaft, and removed waste

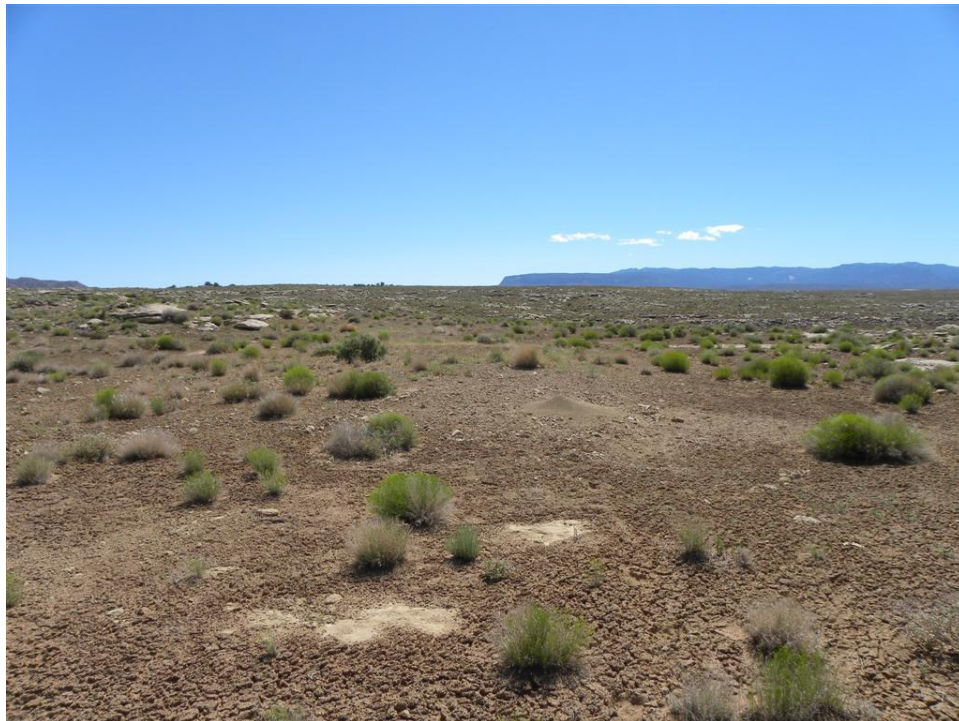
Former shaft area (covered), 25'x25', shaft was estimated to be 10' deep by AML

Photo 4. Johnny McCoy 1 site, former shaft area

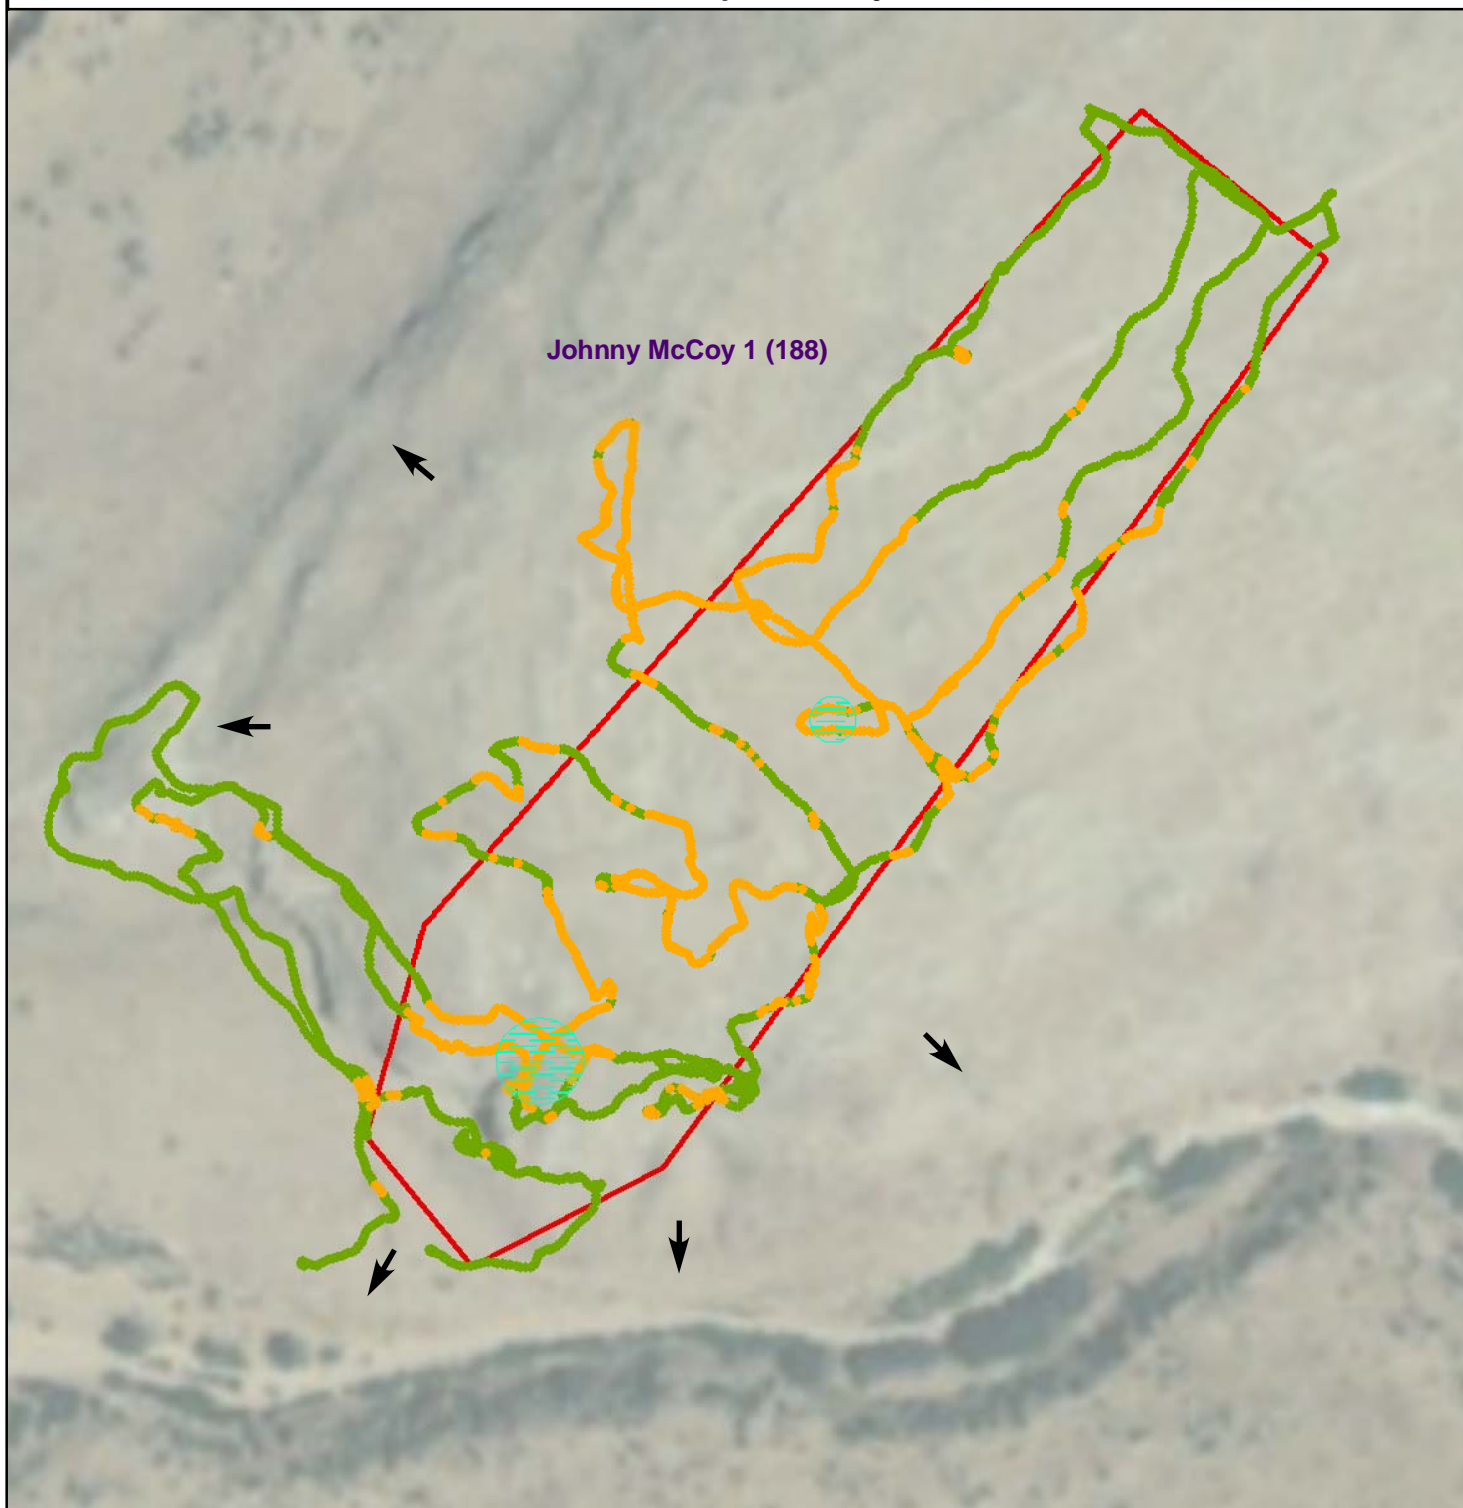
**Figure 1 - Gamma Radiation Measurements, Above Two Times Background
Johnny McCoy 1 (188)
Sweetwater Chapter, Navajo Nation**

A total of 3,142 gamma radiation measurements were collected from the mine site, ranging from 5,710 cpm to 114,582 cpm. Measurements collected in the vicinity of the trench area were found at levels up to approximately 50,000 cpm. The measurements are represented in Figures 1 and 2.

Gamma survey conducted 06/2010
Measured as counts per minute (cpm)

Average background = 7,749 cpm

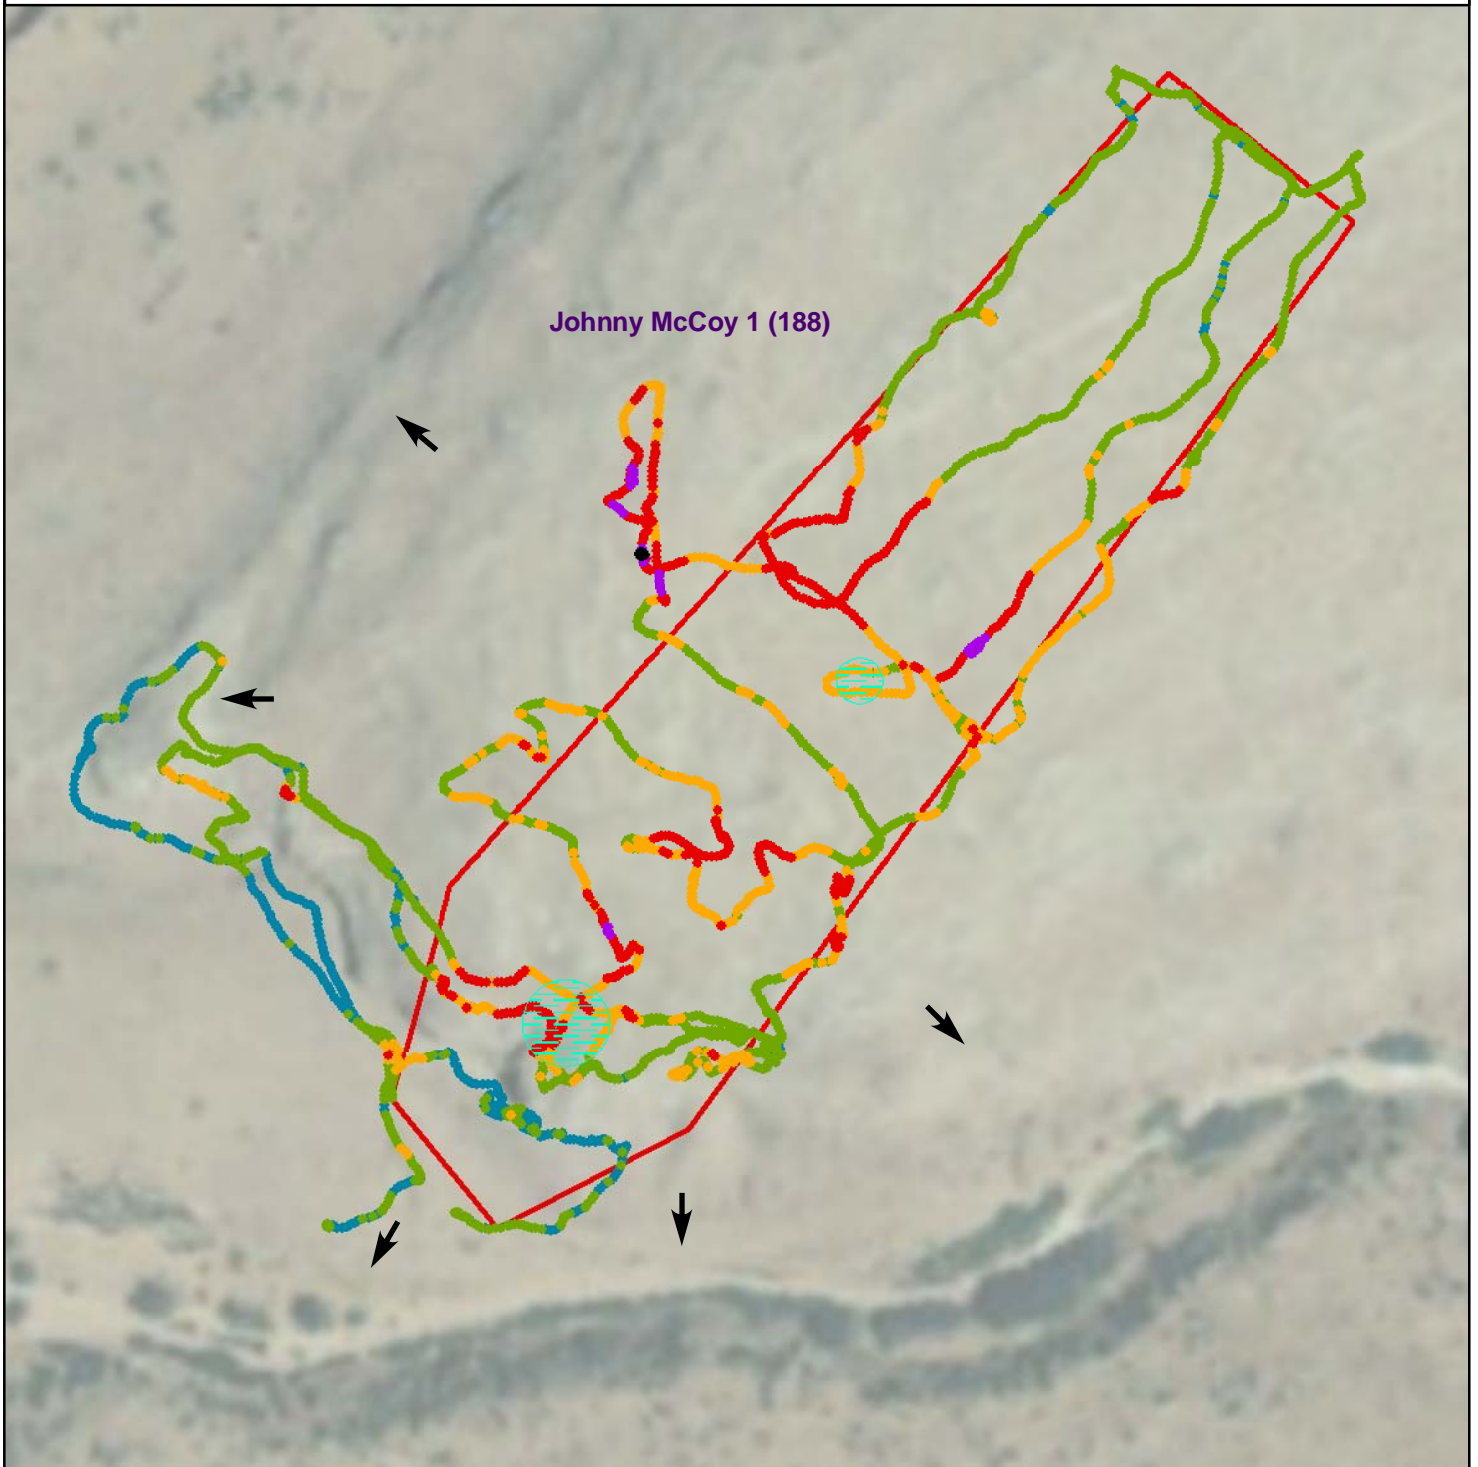
Figure 2 - Gamma Radiation Measurements
Johnny McCoy 1 (188)
Sweetwater Chapter, Navajo Nation

Gamma survey conducted 06/2010
 Measured as counts per minute (cpm)

Average background 7,749 cpm
